*Source Control Evaluation  
Operable Unit 1  
Swan Island Upland Facility  
Portland, Oregon*

Prepared for:  
Port of Portland

February 20, 2013  
1115-06

Ash Creek Associates  
A Division of Apex Companies, LLC

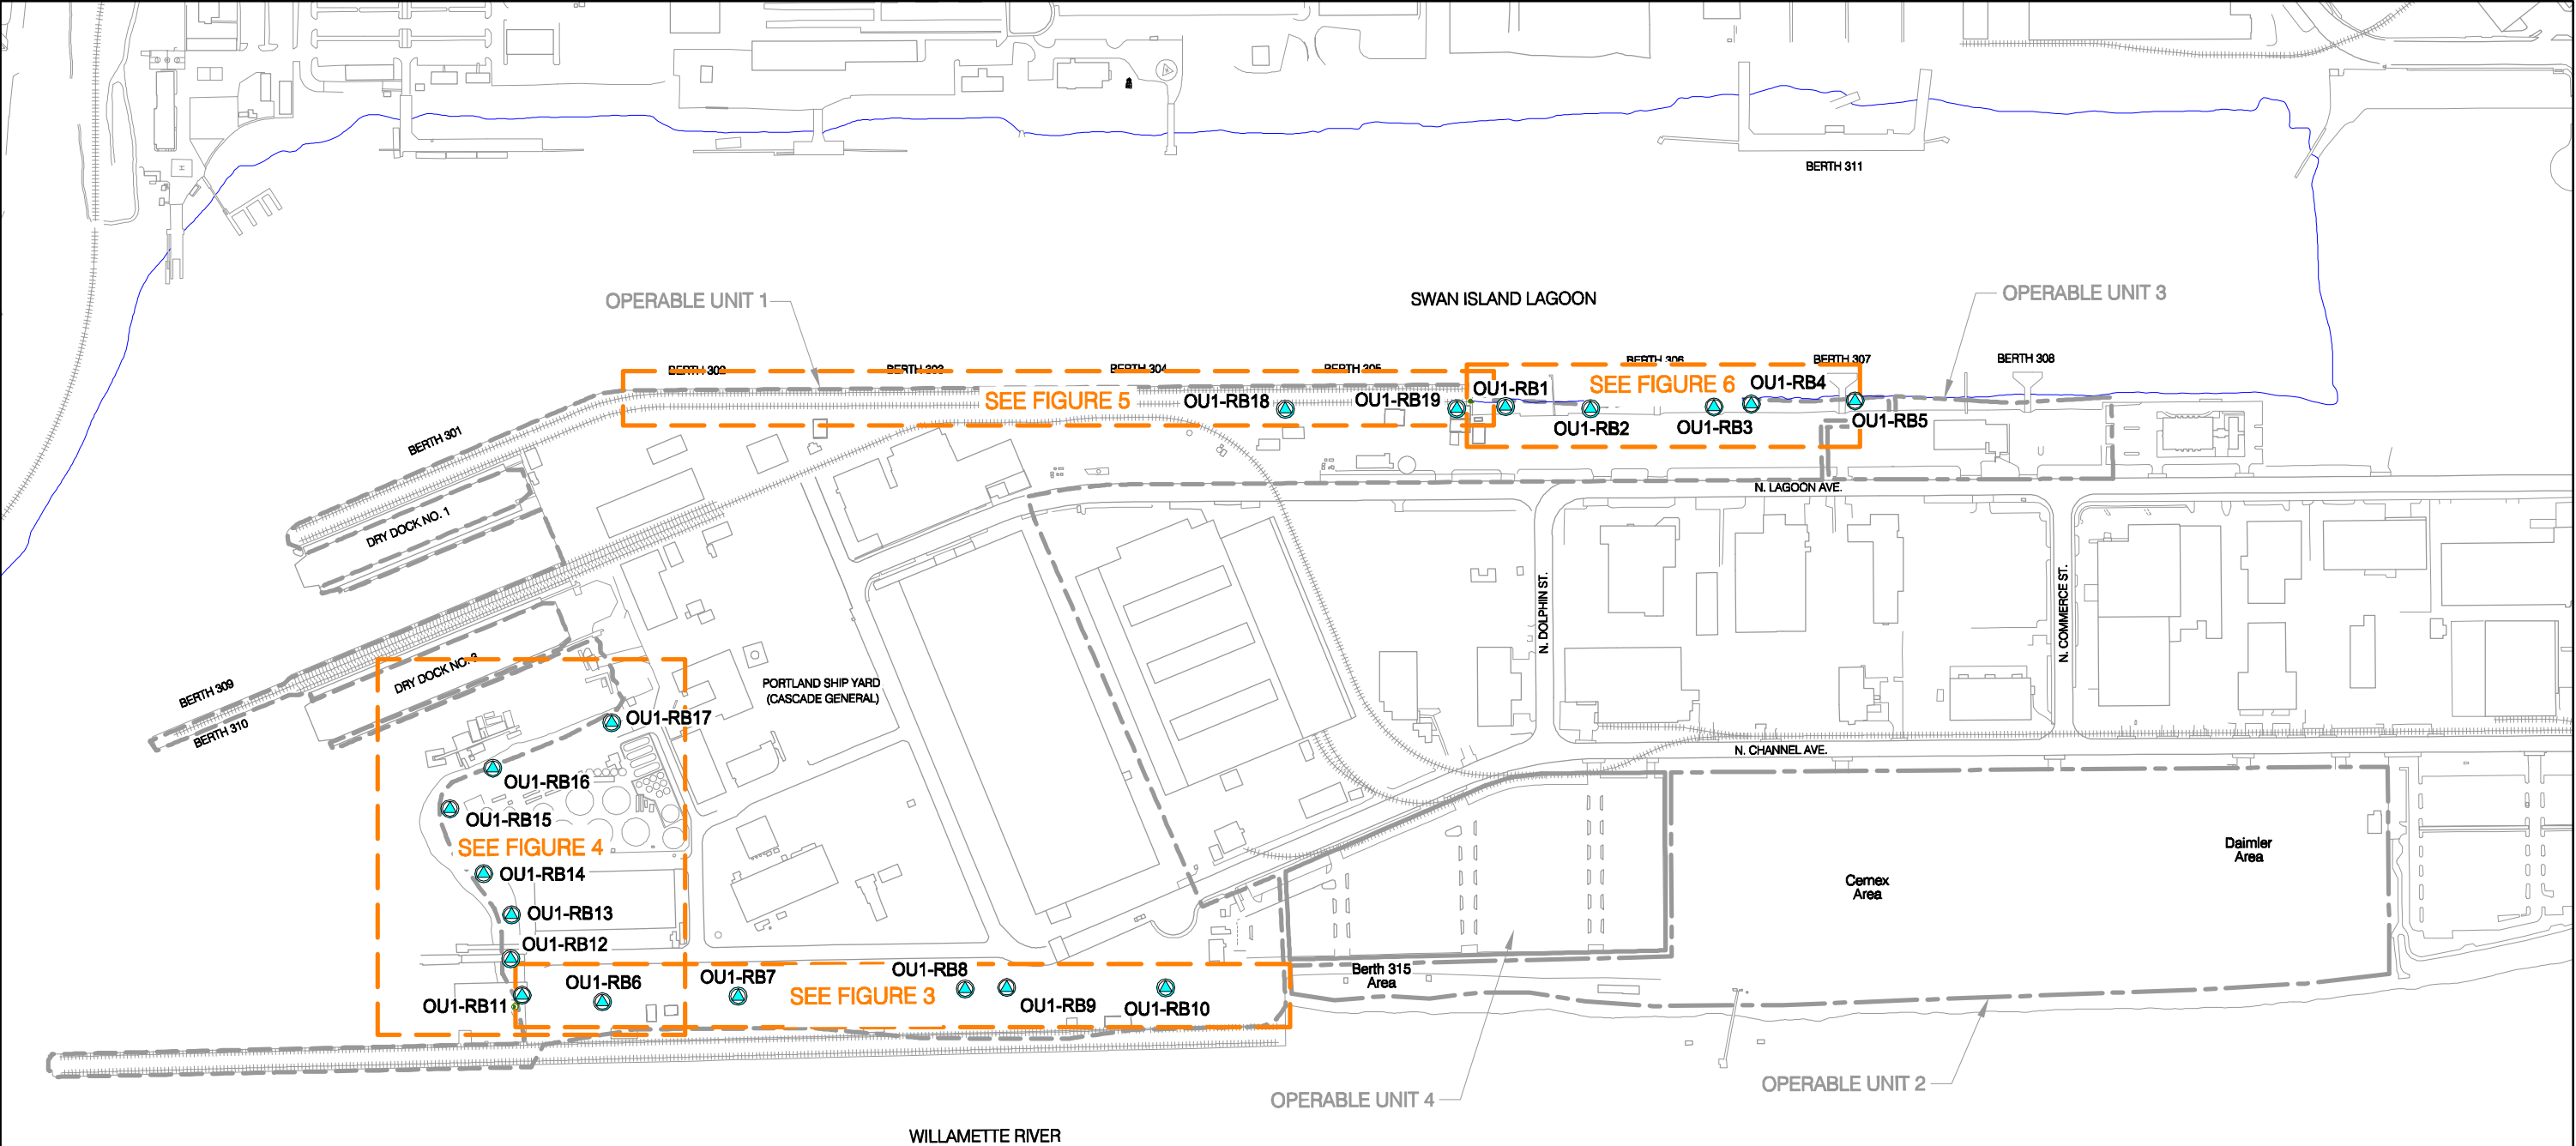
<h2>River Side Docks</h2> <p>Source Control Evaluation Swan Island Upland Facility Operable Unit 1 Portland, Oregon</p>

**River Side Docks.** The river side dock area is shown on Figure 3. This area consists of a concrete wharf on concrete pilings overlying the riverbank. The riverbank under the wharf is characterized by near complete rip rap armoring from below the OLHW to a steel sheetpile bulkhead near the top of slope beneath the wharf. Between the OLHW and the sheetpile bulkhead is a series of erosion scarps. The locations, lengths, and heights of the scarps are shown on Figure 3, and the scarps are shown on Photographs 1 through 7. The erosion scarps are linear or slightly concave features running parallel to the riverbank. Exposed materials in most of the scarps consist of cemented sand, gravel, and rip rap. Four of the scarps (H, I, N, and X) are composed of loose material. Where the riverbank is covered with rip rap, there are no visible signs of erosion, demonstrating that rip rap armoring is effective in this area.
